UNDERWATER BRIDGE INSPECTION REPORT

STRUCTURE NO. 7111

BIG FORK RIVER

MINNESOTA DEPARTMENT OF TRANSPORTATION
UNDERWATER BRIDGE INSPECTION

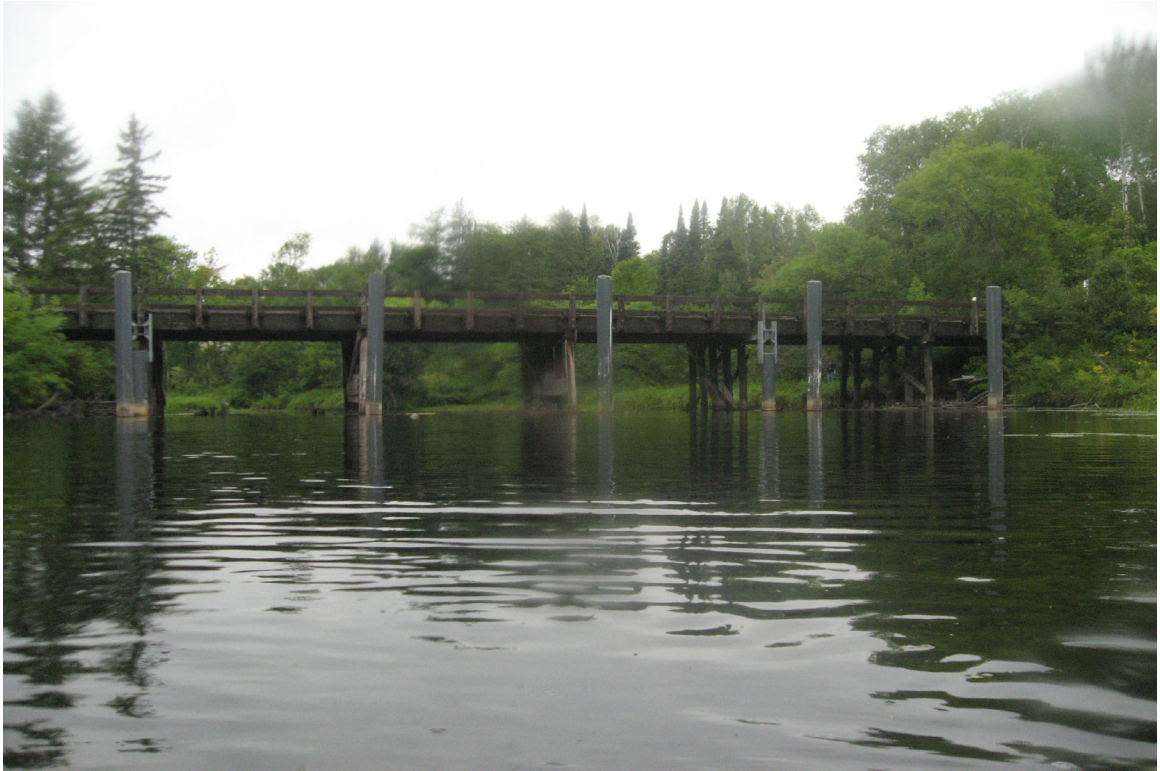
- (C) Moderate to heavy timber debris was observed along the North face and upstream piles of all the piers.
- (D) The 2nd pile in from the upstream fascia of Pier 2 exhibited significant damage, consisting of a 3 inch wide split through the entire pile diameter with some related internal decay.
- (E) Both banks under the bridge exhibited signs of erosion.
- (F) A number of the horizontal pier protection planks at Piers 2 and 3 were damaged and missing section due to drift and ice related abrasion.

Photograph 1. Overall View of the Structure, Looking West.

- (A) All deficient cross bracing should be renewed at the piers to restore the original overall lateral stability of bridge.
- (B) Remove timber drift at the bridge to prevent additional build-up and to eliminate potential for abrasion or scour damage and excessive lateral loads on the piers. Until drift can be removed, closely monitor the accumulations at the bridge especially during any high water events.

- (C) Since it appears that the bridge is prone to drift build-up, it is recommended that consideration be given to implementing a regular program of drift monitoring and removal.

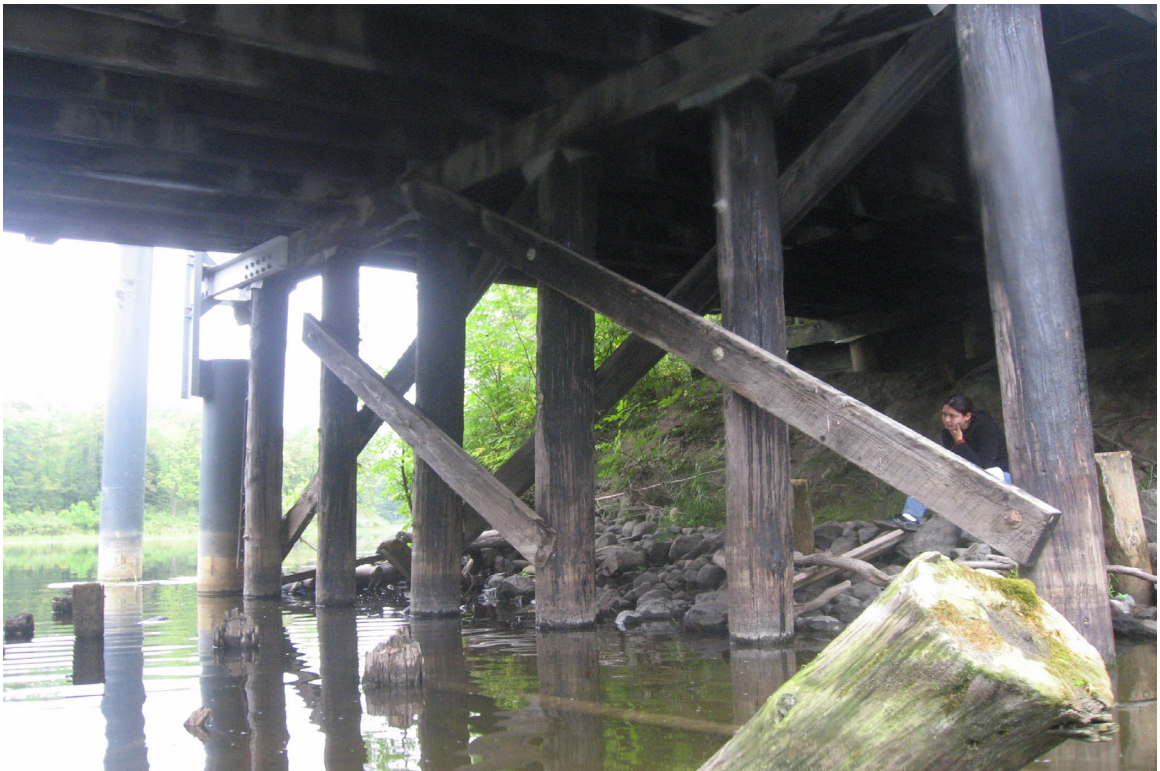
Photograph 2. View of Pier 1, Looking Southeast.

- 21
- The upstream pile at Pier 1 exhibited delamination and splintering above the waterline that was up to 2 feet wide by 1 inch deep.
- 22
- The timber cross bracing exhibited a 2-foot-long by 1/4-inch-wide split through the connection to the third pile from the upstream end of Pier 3.

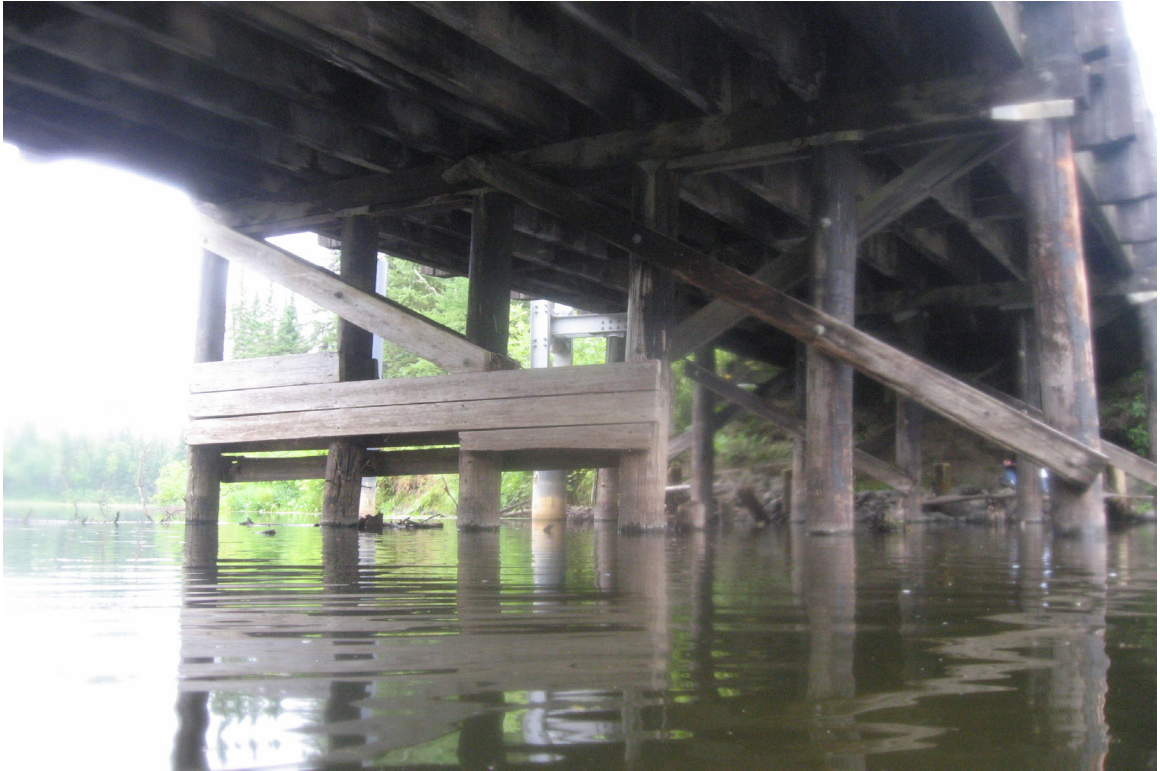
Photograph 3. View of Pier 2, Looking Southeast.

- 11
- Both shorelines under the bridge exhibited signs of erosion.
- 12
- A 3 inch wide split/crack through the entire pile diameter was observed from 3 feet above the waterline to 6 inches below the waterline. The pile exhibited up to 50 percent loss of section due to moderate decay within the split/crack, and the pile was deflected in the area of the decay due to the lateral loads imposed by the accumulation of debris around the pile.

- 13
- The horizontal timber planking exhibited heavy impact damage from debris and ice.
- 14
- The bottom horizontal timber planking on the north face of Pier 2 was missing from the 1st upstream pile to the 4th pile in from the upstream fascia. The rest of the timber planking on the north face of Pier 2 exhibited heavy damage due to drift and ice flows.

- 20
- The timber cross bracing along Pier 2 at the downstream end exhibited several 5-foot-long cracks, one extending through the connection to the pile.

- (D) The stability and load carrying capacity of Pier 2 should be examined based on the damaged pile, and if found to be insufficient, it may be necessary to supplement the pile with some means of carrying load for the pier. If Pier 2 still has sufficient capacity/stability, given the significantly cracked pile, then future inspections should particularly monitor that pile and pier for any further distress.

The stability and load carrying capacity of Pier 2 should be examined based on the damaged pile, and if found to be insufficient, it may be necessary to supplement the pile with some means of carrying load for the pier. If Pier 2 still has sufficient capacity/stability, given the significantly cracked pile, then future inspections should particularly monitor that pile and pier for any further distress.

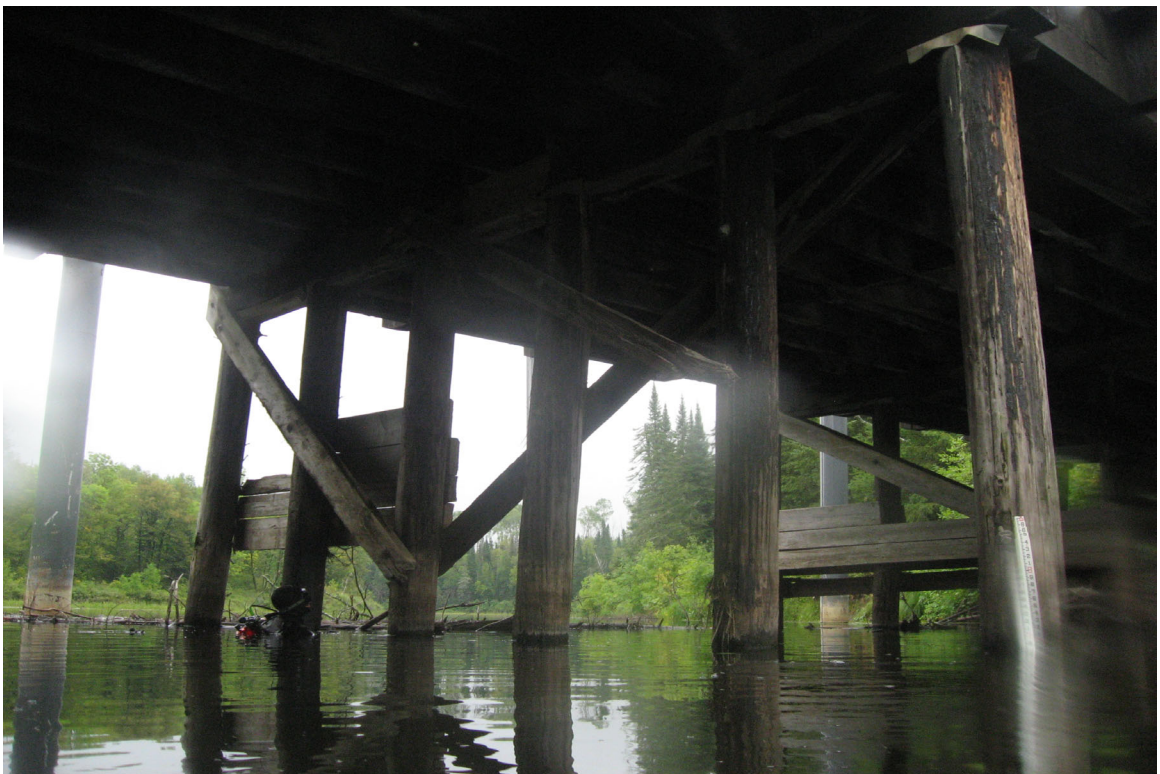
Photograph 4. View of Pier 3, Looking Southeast.

- 15
- The timber cross bracing was broken off on the north face of Pier 3, at the 2nd pile in from the downstream fascia. The timber cross bracing was no longer connected to the 2nd pile in from the downstream fascia.

- 16
- The horizontal timber planking on the south face of Pier 3 was missing from the three upstream piles from 3 feet above to 1 foot above the waterline.

- 17
- Moderate timber debris was observed along the north face and at the upstream pile of Pier 3. The debris extended from the channel bottom to the 3 feet above the channel bottom along the north face, and extended from the channel bottom to 4 feet above the channel bottom at the upstream pile.

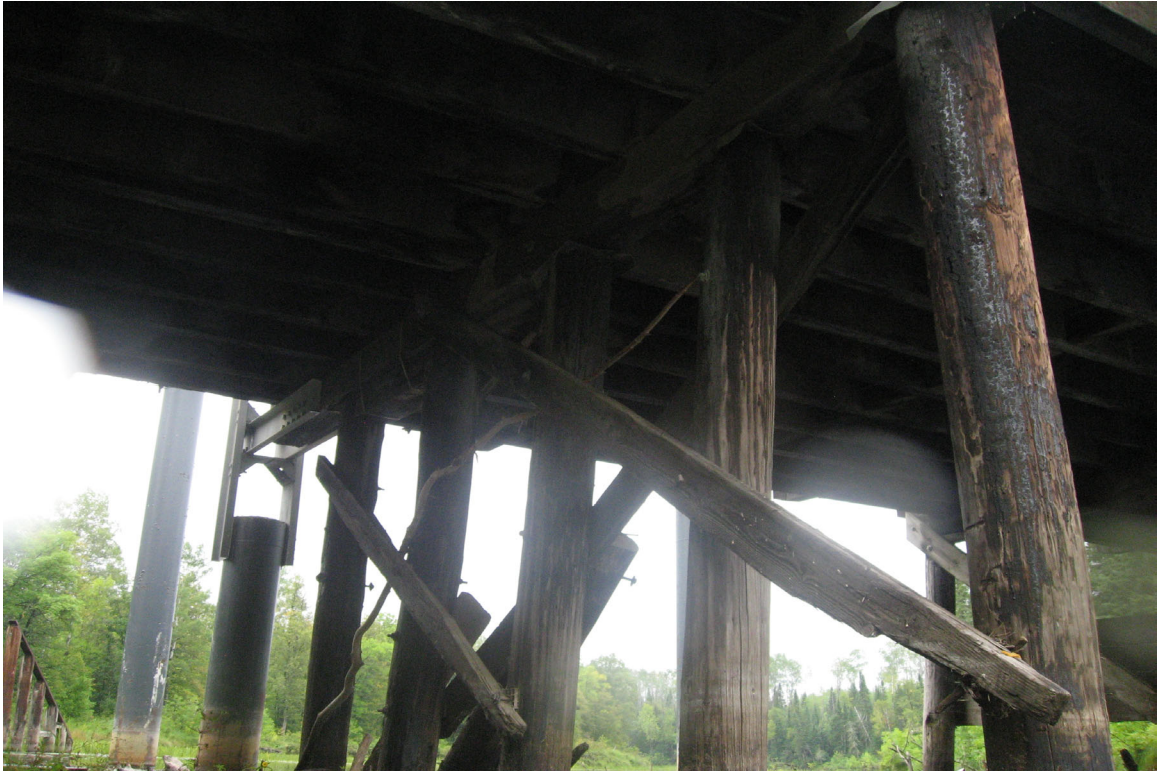
Photograph 5. View of Pier 4, Looking Southeast.

- 9
- Pile exhibited a 1/2 to 1 inch wide crack above the waterline.
- 10
- The timber cross bracing on both the north and south faces had a split extending from the downstream pile to the 3rd pile in from the downstream fascia of Pier 4. The split extended through the connection at the downstream pile and approximately 3 feet of the timber bracing under the split was broken away.

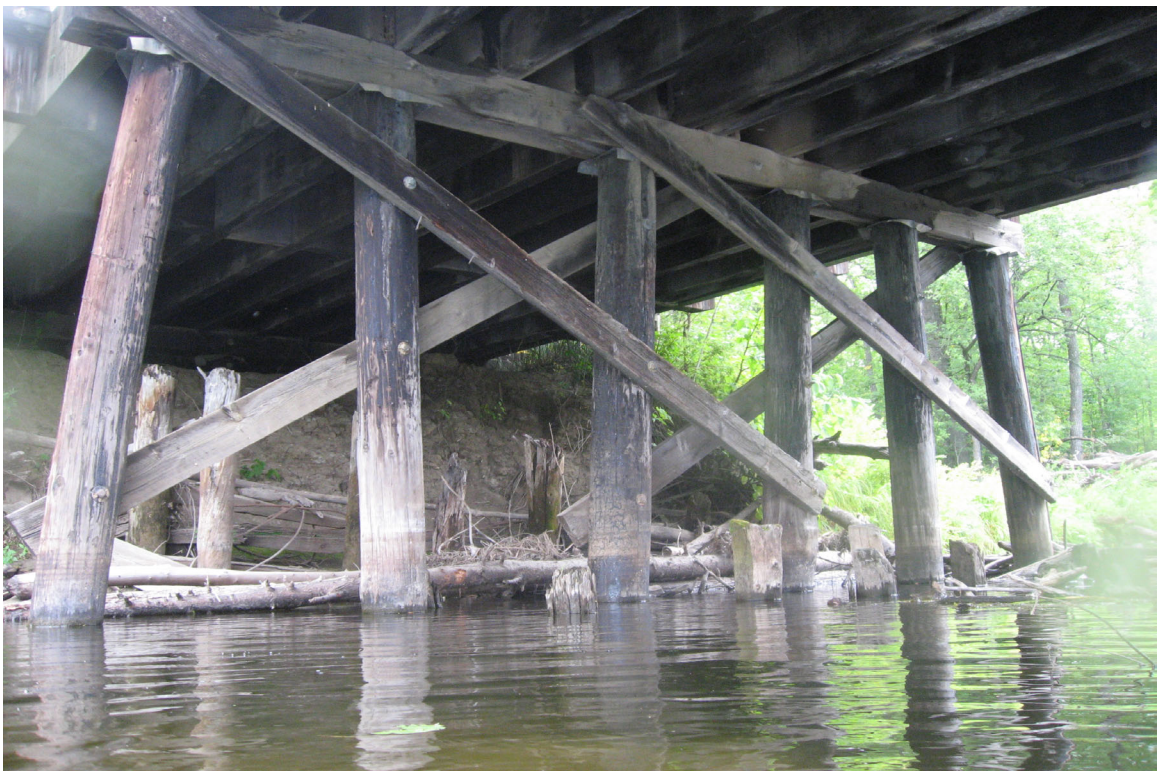
Photograph 6. View of Pier 5, Looking Northeast.

- 23
- The timber cross bracing exhibited two 1/4-inch wide splits through the connection to the upstream pile and the third pile from the upstream end of Pier 5.

- 24
- The timber cross bracing exhibited 2-foot-long by 1/4-inch wide split through the connection at the downstream pile at Pier 5.

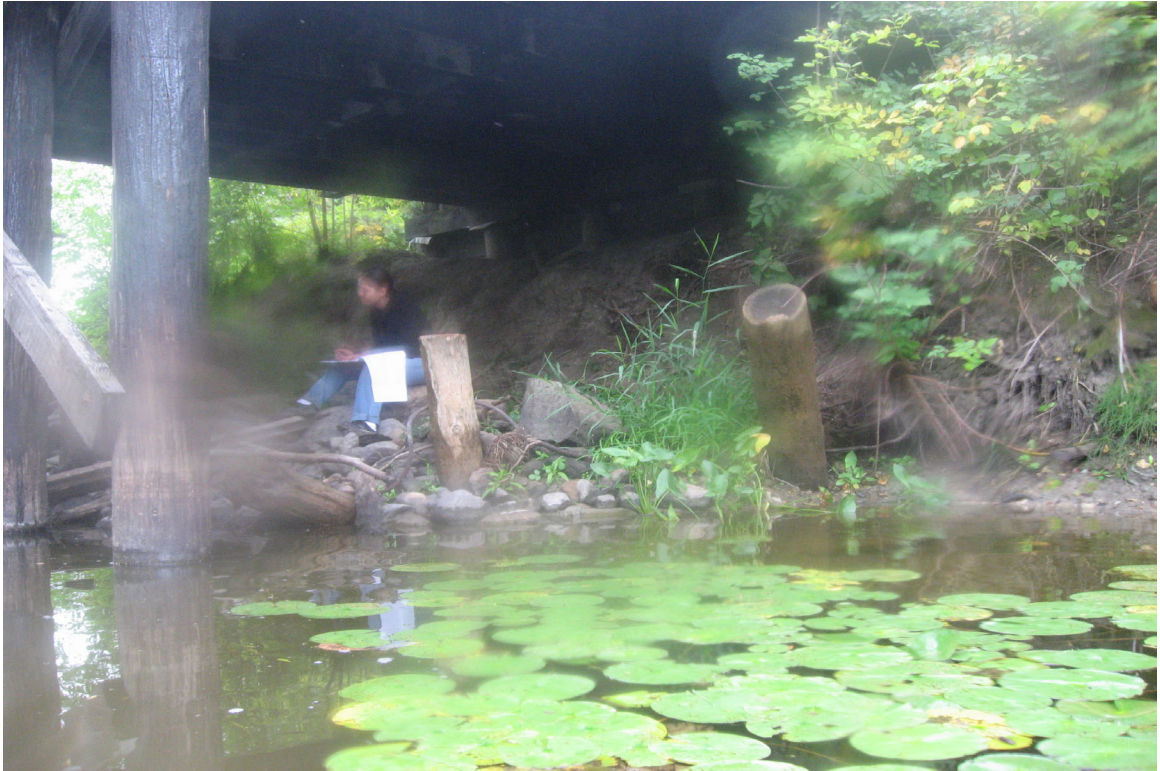
Photograph 7. View of South Abutment, Looking Southeast.

- (E) The channel banks under the bridge should be monitored, and if erosion continues, channel protection measures may need to be considered.
- (F) Reinspect the bridge on a biannual basis above water to monitor drift until it can be removed. Underwater inspections need only be made at the normal maximum (NBIS) interval of five (5) years, assuming drift is removed in a timely manner. If drift is not removed, an underwater inspection may be required sooner, if drift increases and damage is suspected.

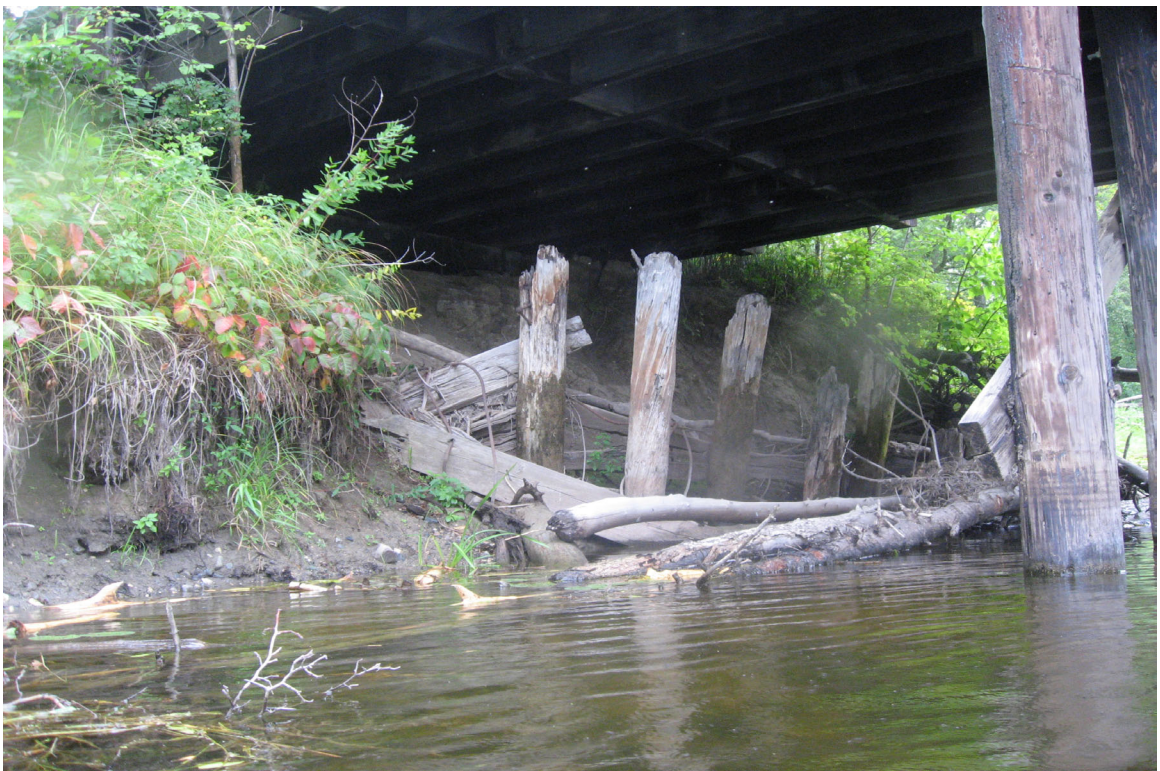
Photograph 8. View of North Abutment, Looking Northeast.

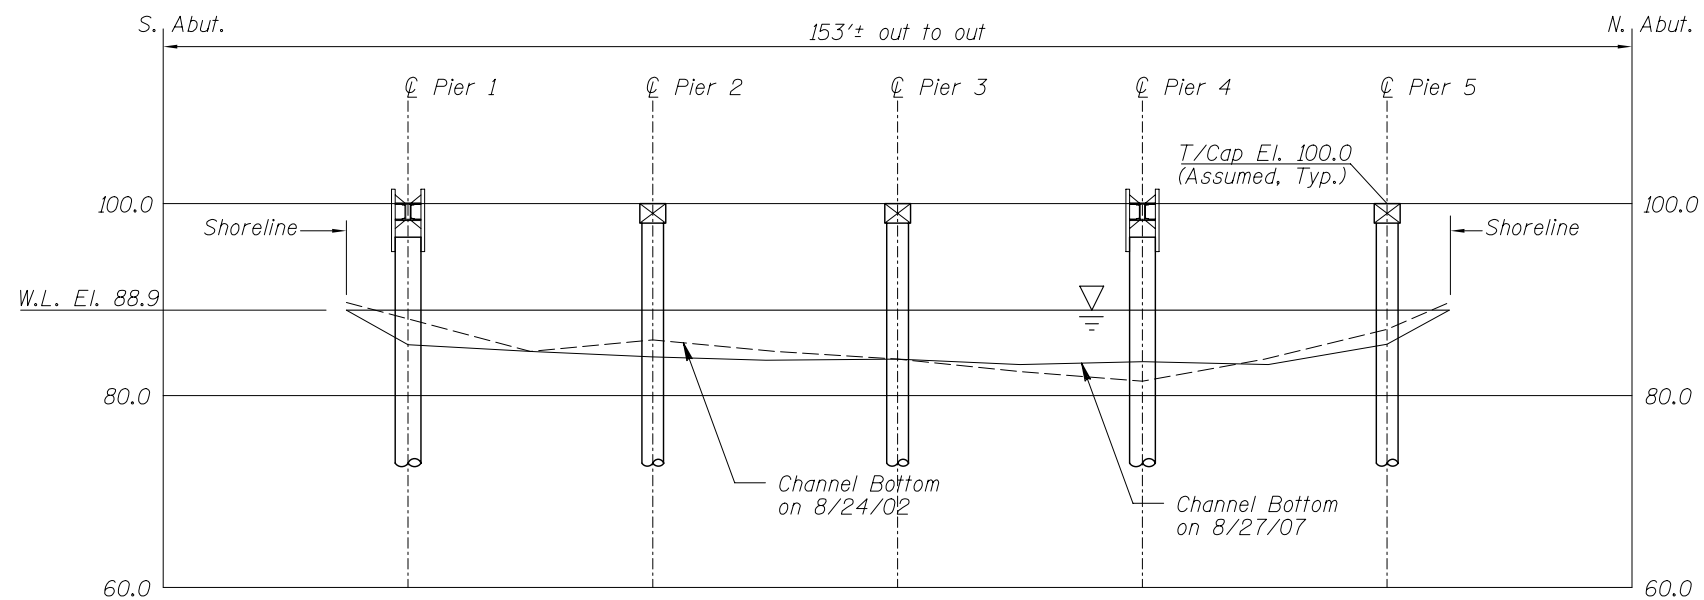
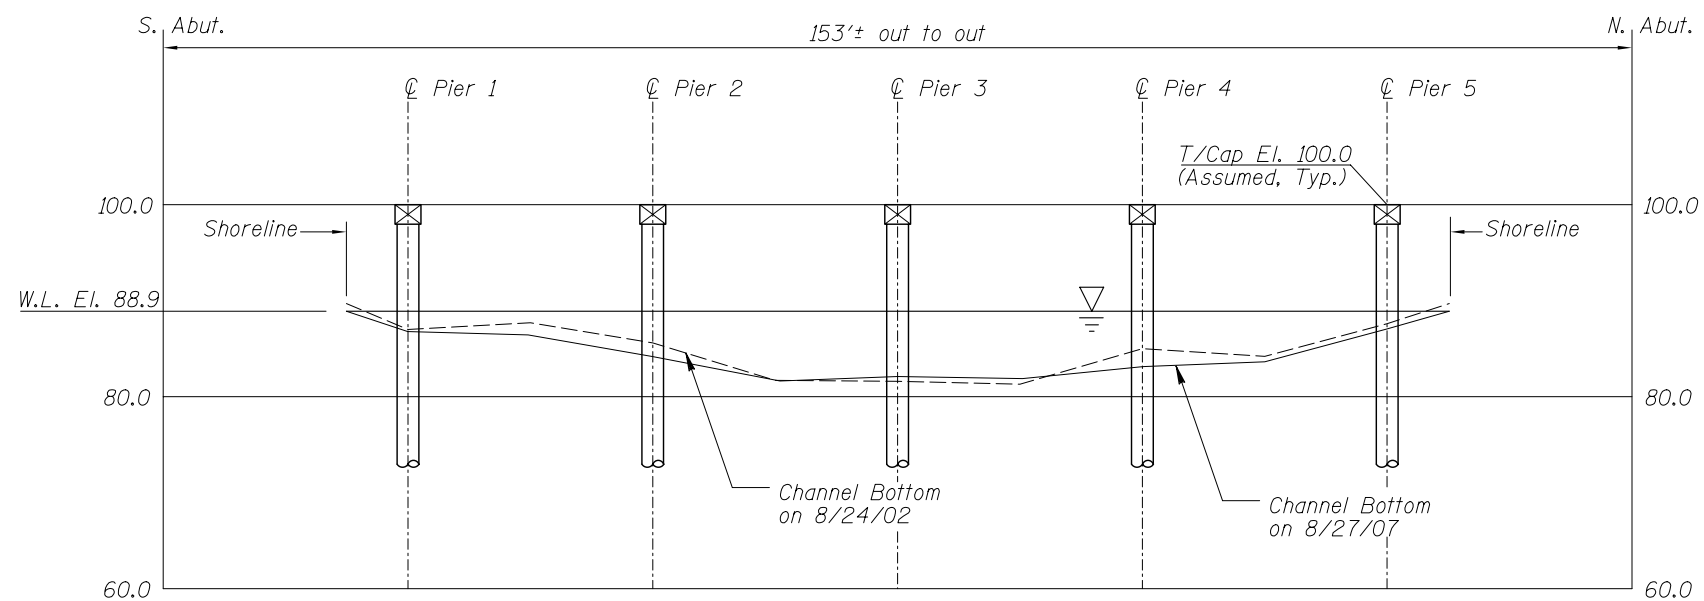
Figure No.: 3

- 8
- All substructure timber was observed to be in sound and firm condition with minor 1/8 inch wide checking below the water. All piles exhibited frequent 1/8 inch to 1/2 inch wide cracking, splintering, and abrasion damage, with typical loss of section between 5 and 15 percent, due to drift or ice impact and rubbing above water.
